# Manhole Inspection Summary

Manhole # S39YY\_020MH

Insp Date: **12/14/06 8:53 AM**

**Location** Address: **3302 ELLERSLIE AVE**

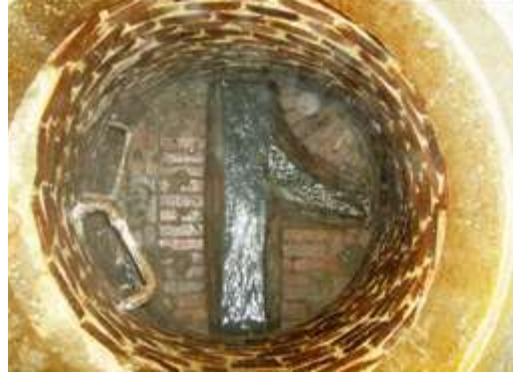
Top View

Corroded steps. Evidence of surcharge - Bench debris.

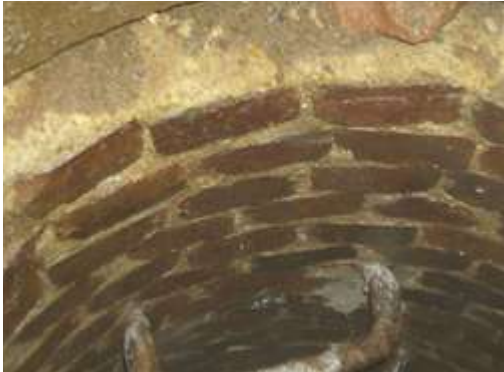
Defect

Frame leaks. Frame offset. Adjustment deterioration, loose brick and infiltration.

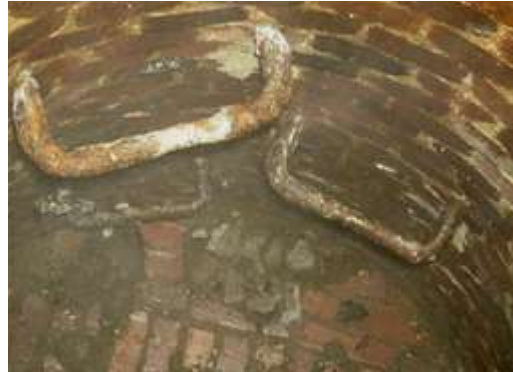
Defect

Barrel infiltration.

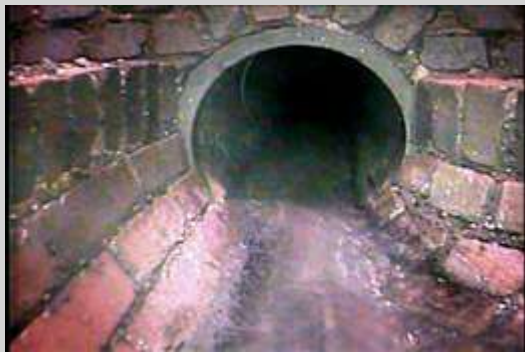
### 12 in. Circular Gravity Sewer Pipe Out @ 12 O'Clock

Channel deterioration.

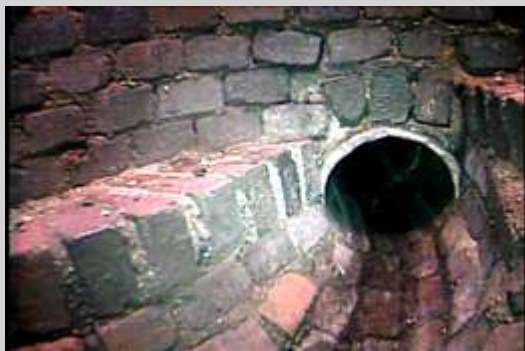
### 8 in. Circular Gravity Sewer Pipe In @ 3 O'Clock

Barrel deterioration and infiltration.

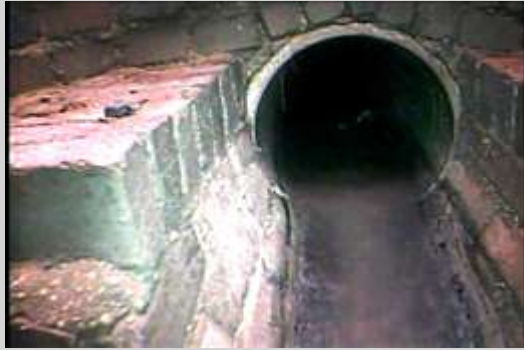
Pipe In @ 6 O'Clock

Infiltration: **Evidence** Pipe Seal Cond: **Cracked**
